RE: Phase I Fault Study

Wirt Road Drainage and Pavement Sub-Project II

WBS No. M-000287-002-3

City of Houston, Harris County, Texas

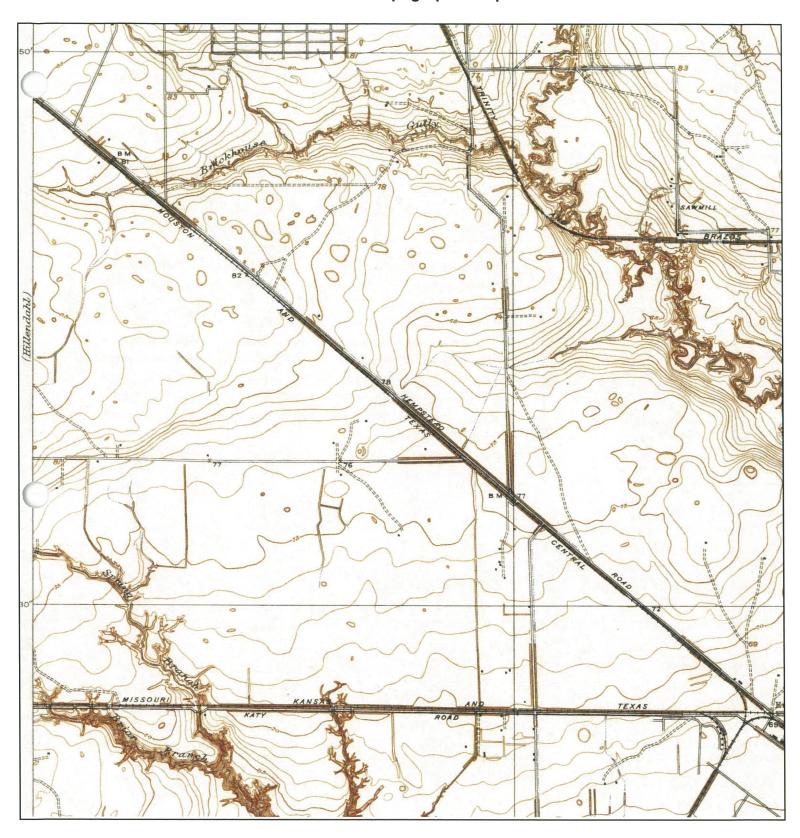
MAP YEAR: 1922

The 1922 topographic map is the only topographic map with a 1-foot contour interval. The relatively closely spaced contour lines in the area proximal to Long Point Road (to the west of the drawn-in fault symbol) as compared to the generalized regional topography exclusive of creeks and gullies in the area suggests the presence of the scarp of the Long Point Fault. The contour interval on the remaining topographic maps is 5 feet, with resultant loss of detail necessary to identify the presence of the Long Point Fault.

Note, however, that the surficial elevation of the area of Wirt Road immediately south of Amelia Road (which runs parallel to and one block north of Long Point Road) is mapped as decreasing from approximately 80 feet above mean seal level (+80' MSL) in 1922, 1946, 1955, and 1967 to approximately +78' MSL in 1982 and 1995. This apparent decrease in elevation in the study area may be related to regional groundwater withdrawal, which has been postulated to be associated with reactivation of the Long Point Fault during urbanization of the Houston area (Verbeek and Clanton, 1981).

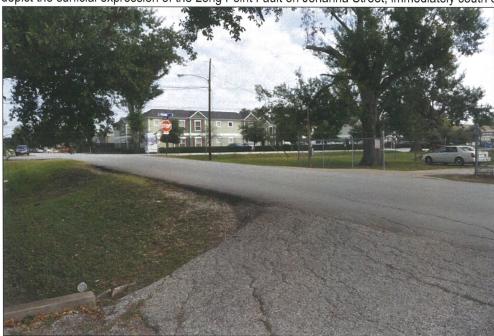
Photo No. 1: Facing northeast, this is a view near the intersection of Amelia Road (trending east-west) and Johanna Street (trending north-south), the southward slope of the Johanna Street surface (south of Amelia Road) indicates the presence of Long Point Fault. Johanna Street parallels and is located one block east of Wirt Road.

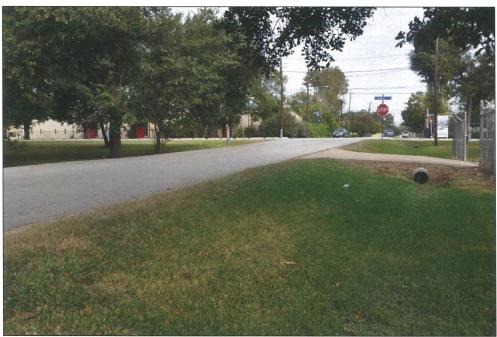
Photo No. 2: Facing north-northwest, this is a view near the intersection of Amelia Road and Johanna Street. The southward-sloping surface of Johanna Street indicates the presence of the Long Point Fault. The blue cars in the background are on the upthrown side of the fault; and the photograph was taken from the downthrown side of the fault.

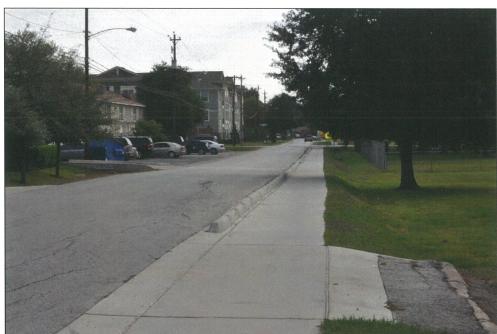
Photo No. 3: Facing east, this is a view of Amelia Road near its intersection with Johanna Street. The Long Point Fault crosses Amelia Road at a low angle. The tree's shadow on the sidewalk and roadway is near the area of greatest fault-related deformation. The photograph was taken from the upthrown side of the fault, and the downthrown side of the fault is visible in the background area of the photograph.

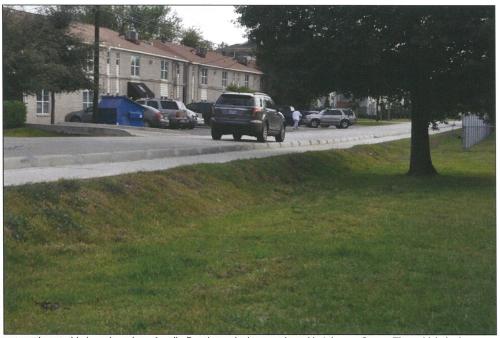
Photo No. 4: Facing east-northeast, this is a view along Amelia Road near its intersection with Johanna Street. The vehicle in the center of the photograph is crossing from the upthrown side to the downthrown side of the Long Point Fault.

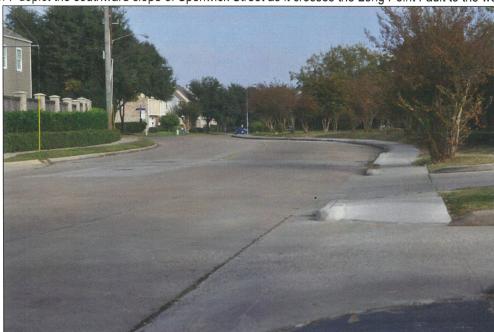
Photo No. 5: Facing north-northwest, this is a view along Spenwick Street south of its intersection with Amelia Road. The photograph was taken from the downthrown side of the Long Point Fault, and the blue vehicle in the background is on the upthrown side of the fault. Spenwick Street parallels and is located one block west of Wirt Road.

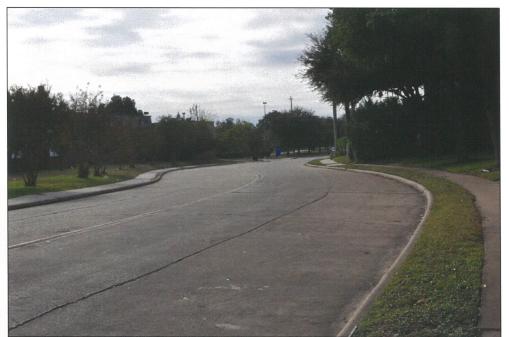
Photo No. 6: Facing south-southeast, this is a view along Spenwick Street near its intersection with Amelia Road. The southward slope of the road surface indicates the presence of the Long Point Fault.

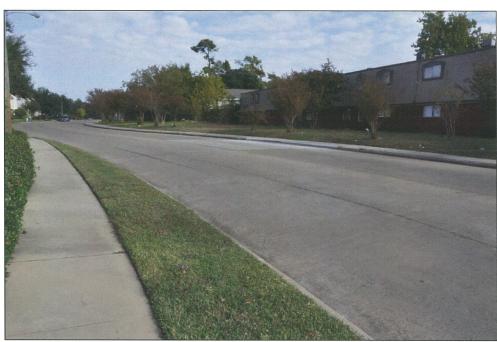
Photo No. 7: Facing northeast, this is a view across Spenwick Street, which slopes southward across the Long Point Fault. A close-up of the apartment building on the east side of Spenwick Street (in the right of this photograph) is presented as Photo No. 8.

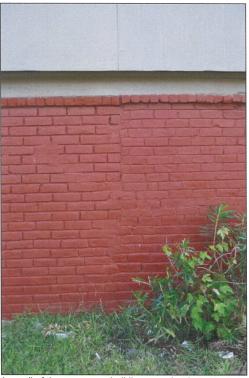
Photo Nos. 8 and 9 show a repair of fault-related structural deformation of the wall of an apartment building located on the east side of Spenwick Street.

Photo No. 8: Facing east, this is a close-up view of the wall of the apartment building seen in Photo No. 7. Irregularities in the brick facing of the building are likely due to structural deformation associated with the Long Point Fault.

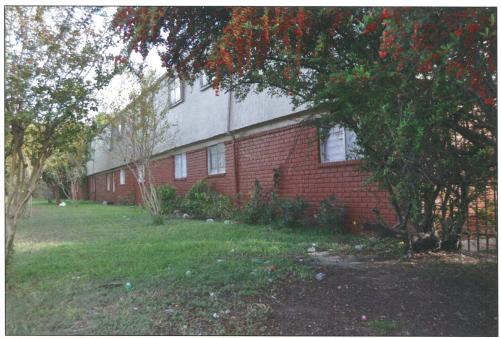
Photo No. 9: Facing northeast, this is a view of the southwest corner of the apartment building.

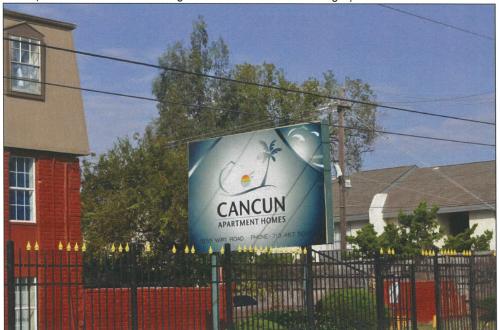
Photo No. 10 shows the location of the Cancun Apartments complex at 1855 Wirt Road. The red buildings of the Cancun Apartments complex shown in Photo No. 10 are located on the downthrown side of the Long Point Fault along Wirt Road. A portion of the Cancun Apartments complex that straddles the Long Point Fault to the west along Spenwick Street is shown in Photo Nos. 8 and 9.

Photo No. 10: Facing northwest along Wirt Road, this is a view of a portion of the Cancun Apartments complex (1855 Wirt Road) that is situated immediately downthrown of the Long Point Fault.

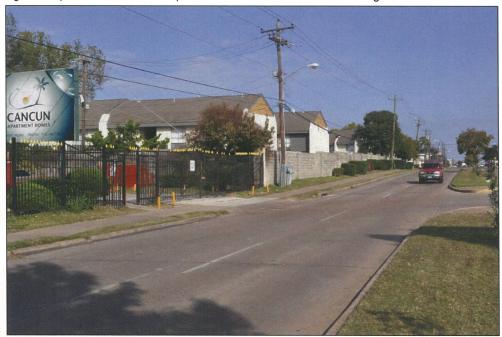
Photo No. 11: Facing north-northwest, this is a view from the median of Wirt Road at 1855 Wirt Road. The red vehicle is crossing from the upthrown to the downthrown side of the Long Point Fault.

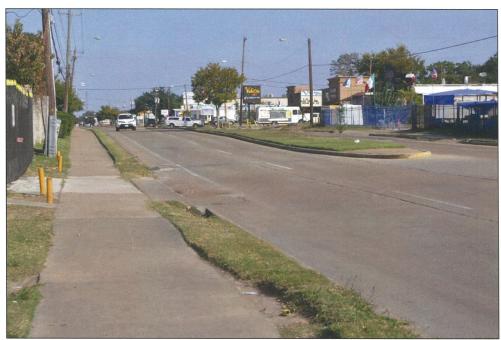
Photo No. 12: Facing north-northeast, this is a view from 1855 Wirt Road. The white vehicle in the left portion of the photograph is about to pass from the upthrown side of the Long Point Fault down the fault scarp.

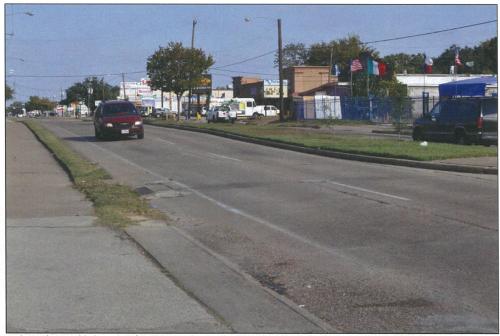
Photo No. 13: Facing north-northeast, this is a view from 1855 Wirt Road. The red car is on the fault scarp between the upthrown and downthrown sides of the Long Point Fault.

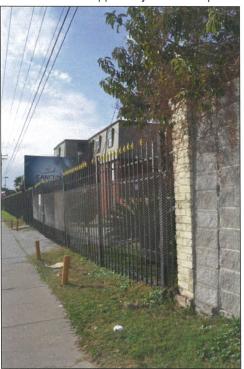
Photo Nos. 14 and 15 show a wall that has been deformed apparently due to the presence of the Long Point Fault

Photo No. 14: Facing south-southwest, this is a view of the property at 1855 Wirt Road. See Photo No. 15 for a detail from this photograph.

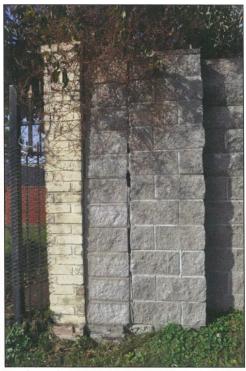
Photo No. 15: Facing west, this is a close-up view near the north property line at 1855 Wirt Road. The offsets along the vertical crack in the gray wall are likely due to deformation associated with the Long Point Fault (upthrown to right, downthrown to left).

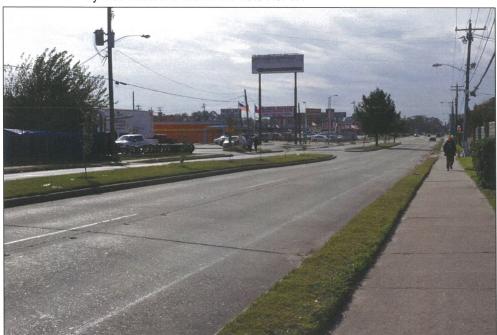
Photo No. 16: Facing south from the west side of Wirt Road, this photograph was taken at or near the upthrown side of the Long Point Fault. Vehicles on Wirt Road are on the downthrown side of the fault.

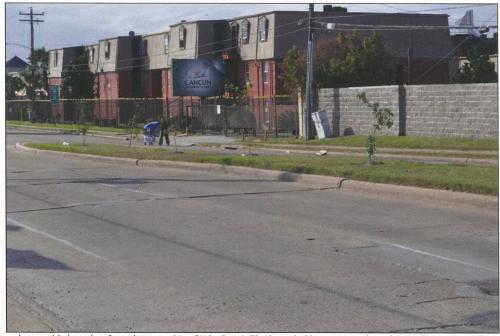
Photo No. 16 depicts the southward slope of Wirt Road as it crosses the Long Point Fault. Structural deformation of the curb along the median of Wirt Road that is likely fault-related is shown in Photo No. 17.

Photo No. 17: Facing southwest, this is a view from the east side of Wirt Road. The irregularities present along the median curb are likely a result of deformation associated with the Long Point Fault.

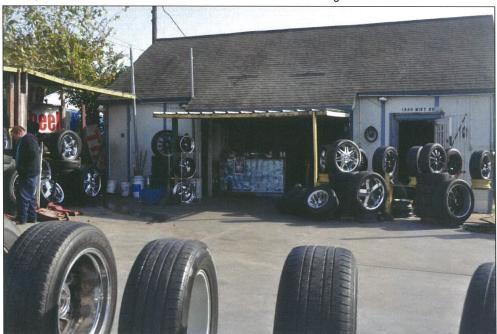
The noticeable southward slope of ground surface along the fault scarp at 1860 Wirt Road is shown in Photo No. 18. The southward slope of Wirt Road as it crosses the Long Point Fault is again shown in Photo No. 19. The business located at 1850-B Wirt Road, as depicted in Photo No. 20, is situated on the downthrown southern side of the Long Point Fault.

Photo No. 18: Facing east, this is a view at 1860 Wirt Road. The water visible in the shadowed area in the left portion of the photograph is flowing downslope along the scarp of the Long Point Fault.

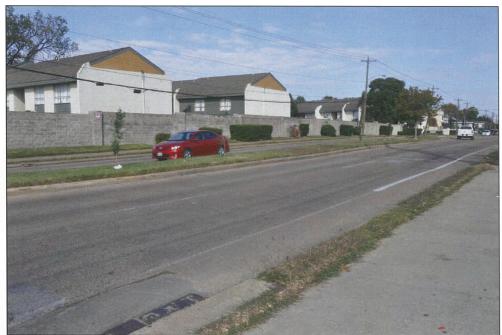
Photo No. 19: Facing northwest, this is a view from 1860 Wirt Road. The red vehicle is travelling south across the scarp of the Long Point Fault.

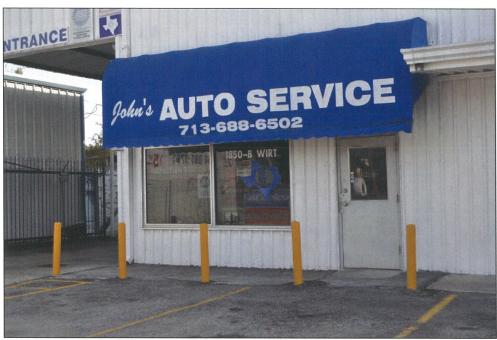
Photo No. 20: Facing east, this is a view the business located at 1850-B Wirt Road, which is situated on the downthrown side of the Long Point Fault.
